**GOLETA WATERSHED COMPREHENSIVE  
AND WATER CONSERVATION PLANNING P**

**GOLETA WATERSHED RI**

**JUNE 1968**

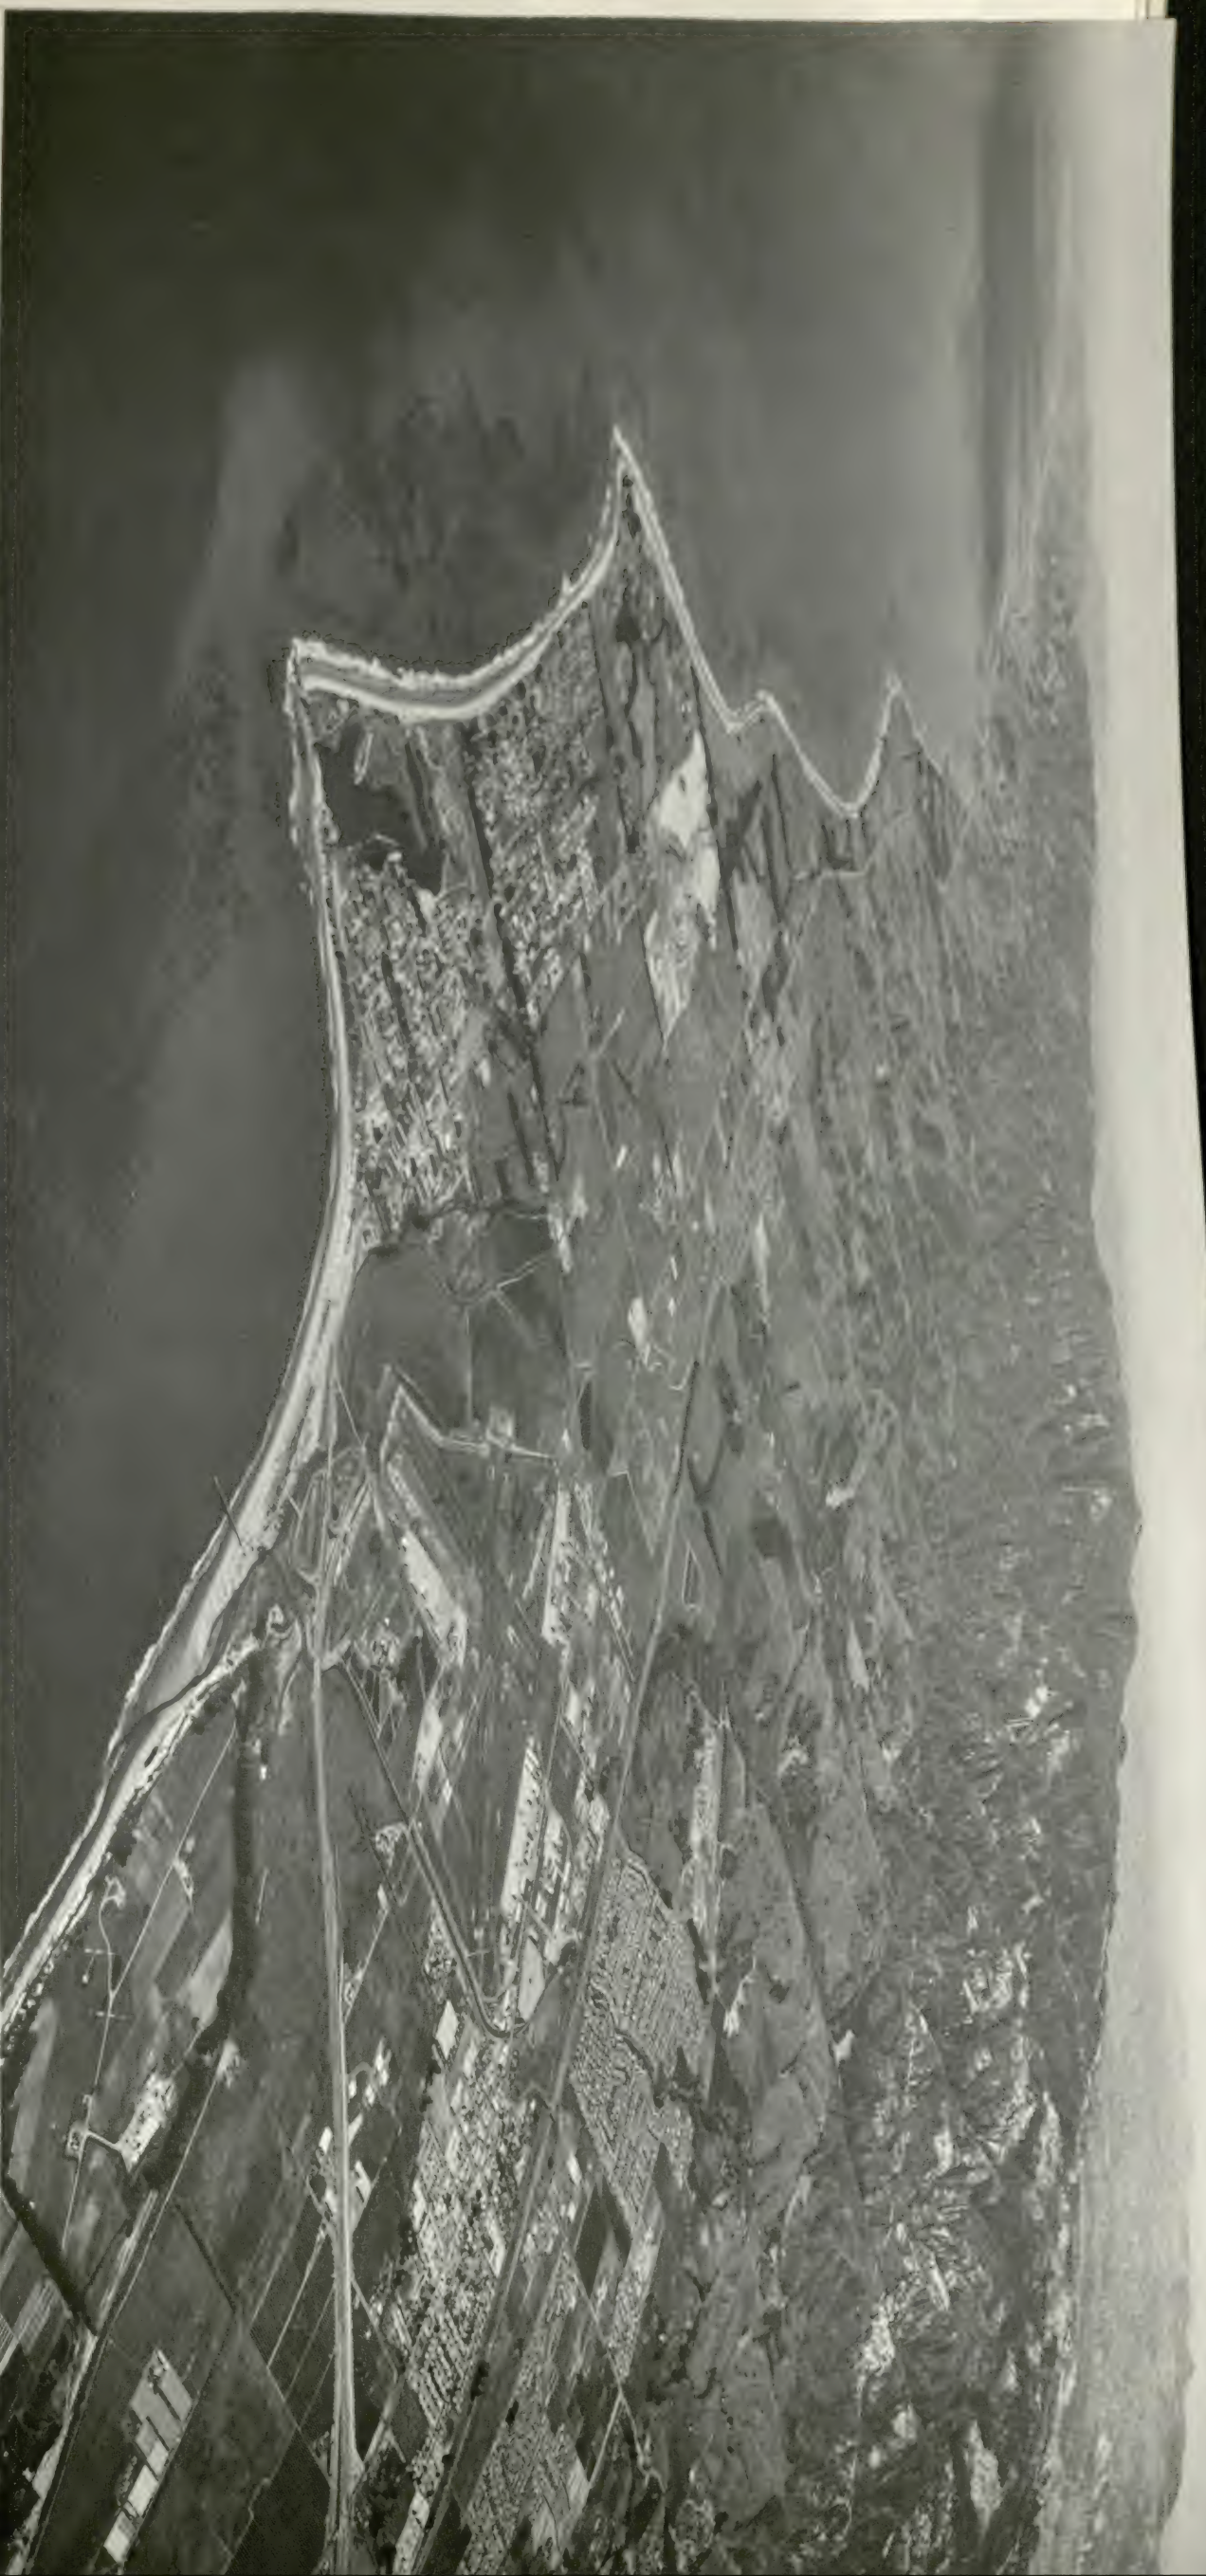
Photo 2. Aerial view of Goleta Valley. Entire watershed drains into the ocean through the Goleta Slough and its outlet in the foreground.

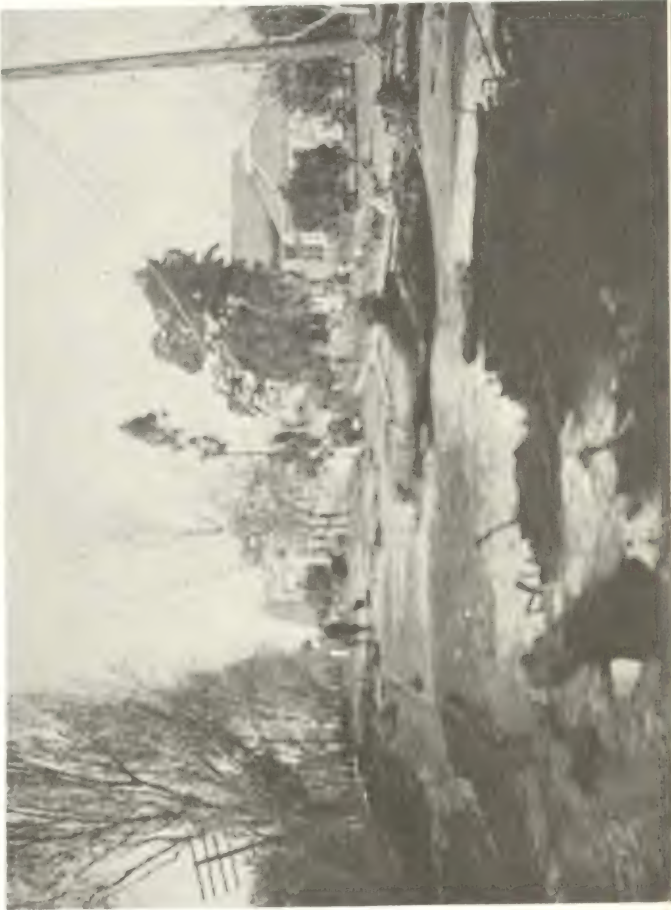
Photo 3. Silt and debris deposits on Hollister Avenue from flood of January 25, 1914.

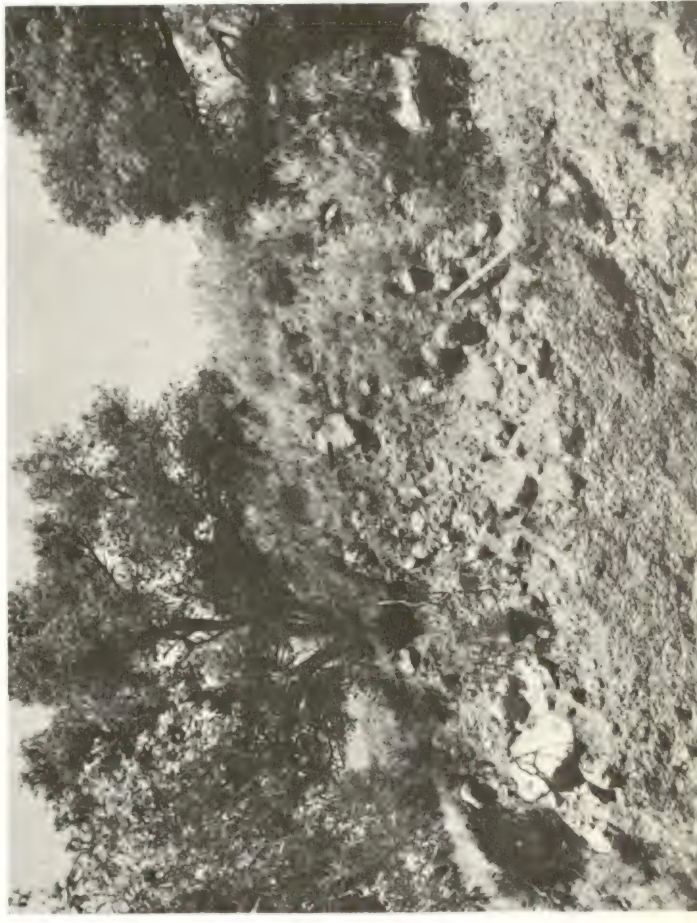
Photo 5. Unconsolidated terrace deposits unconformably overlying Rincon Shale.

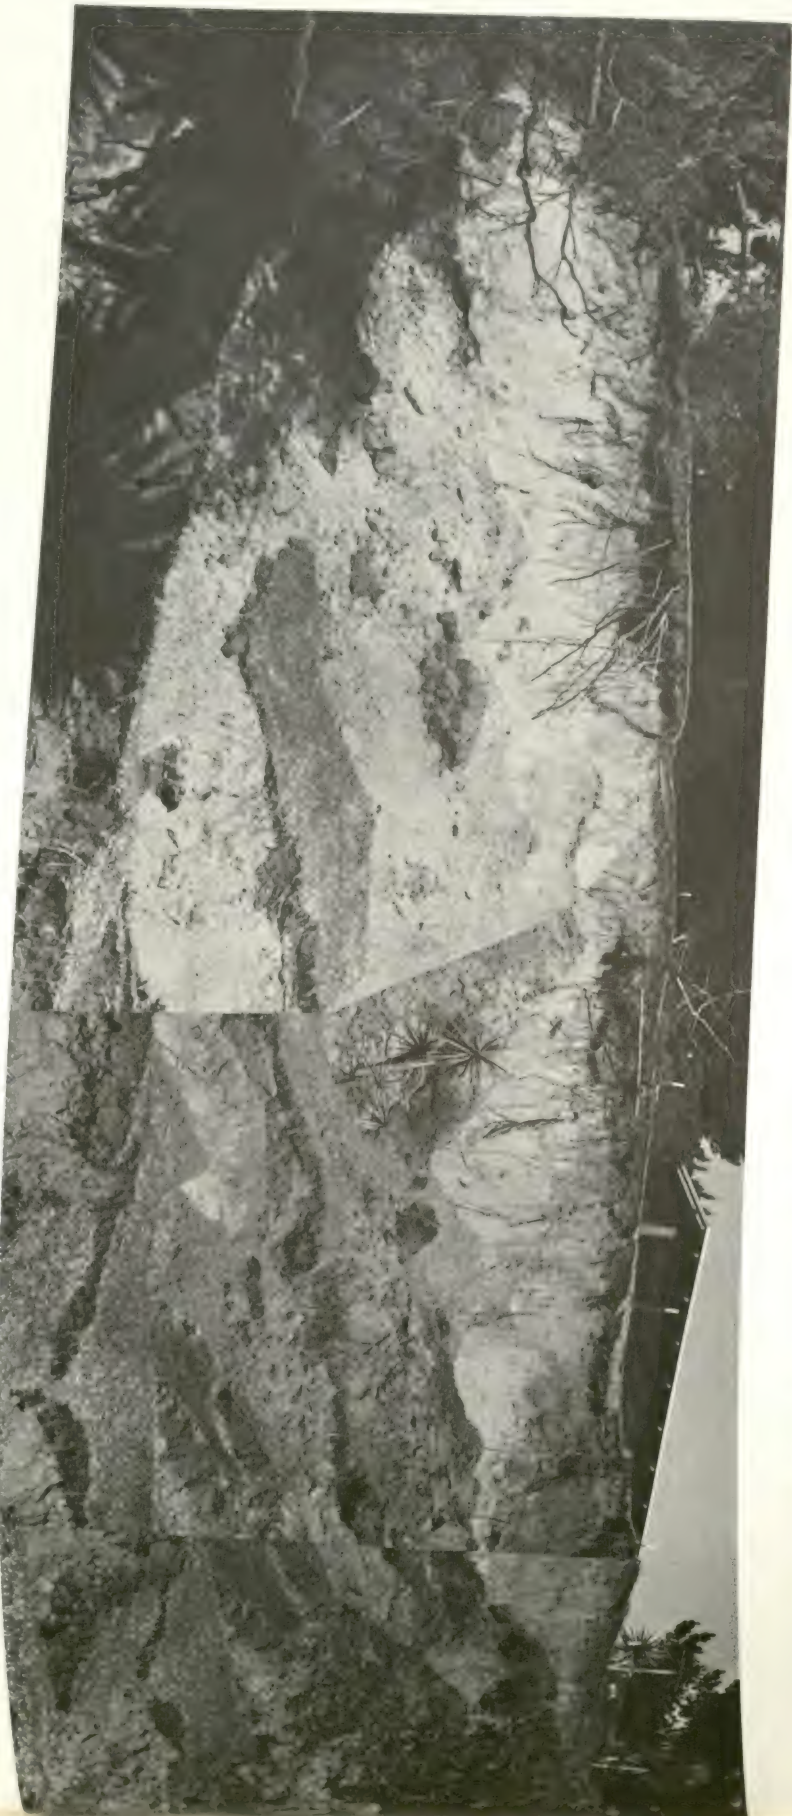
Photo 8. Portion of a landslide in marine terrace sand adjacent to high seaciff.

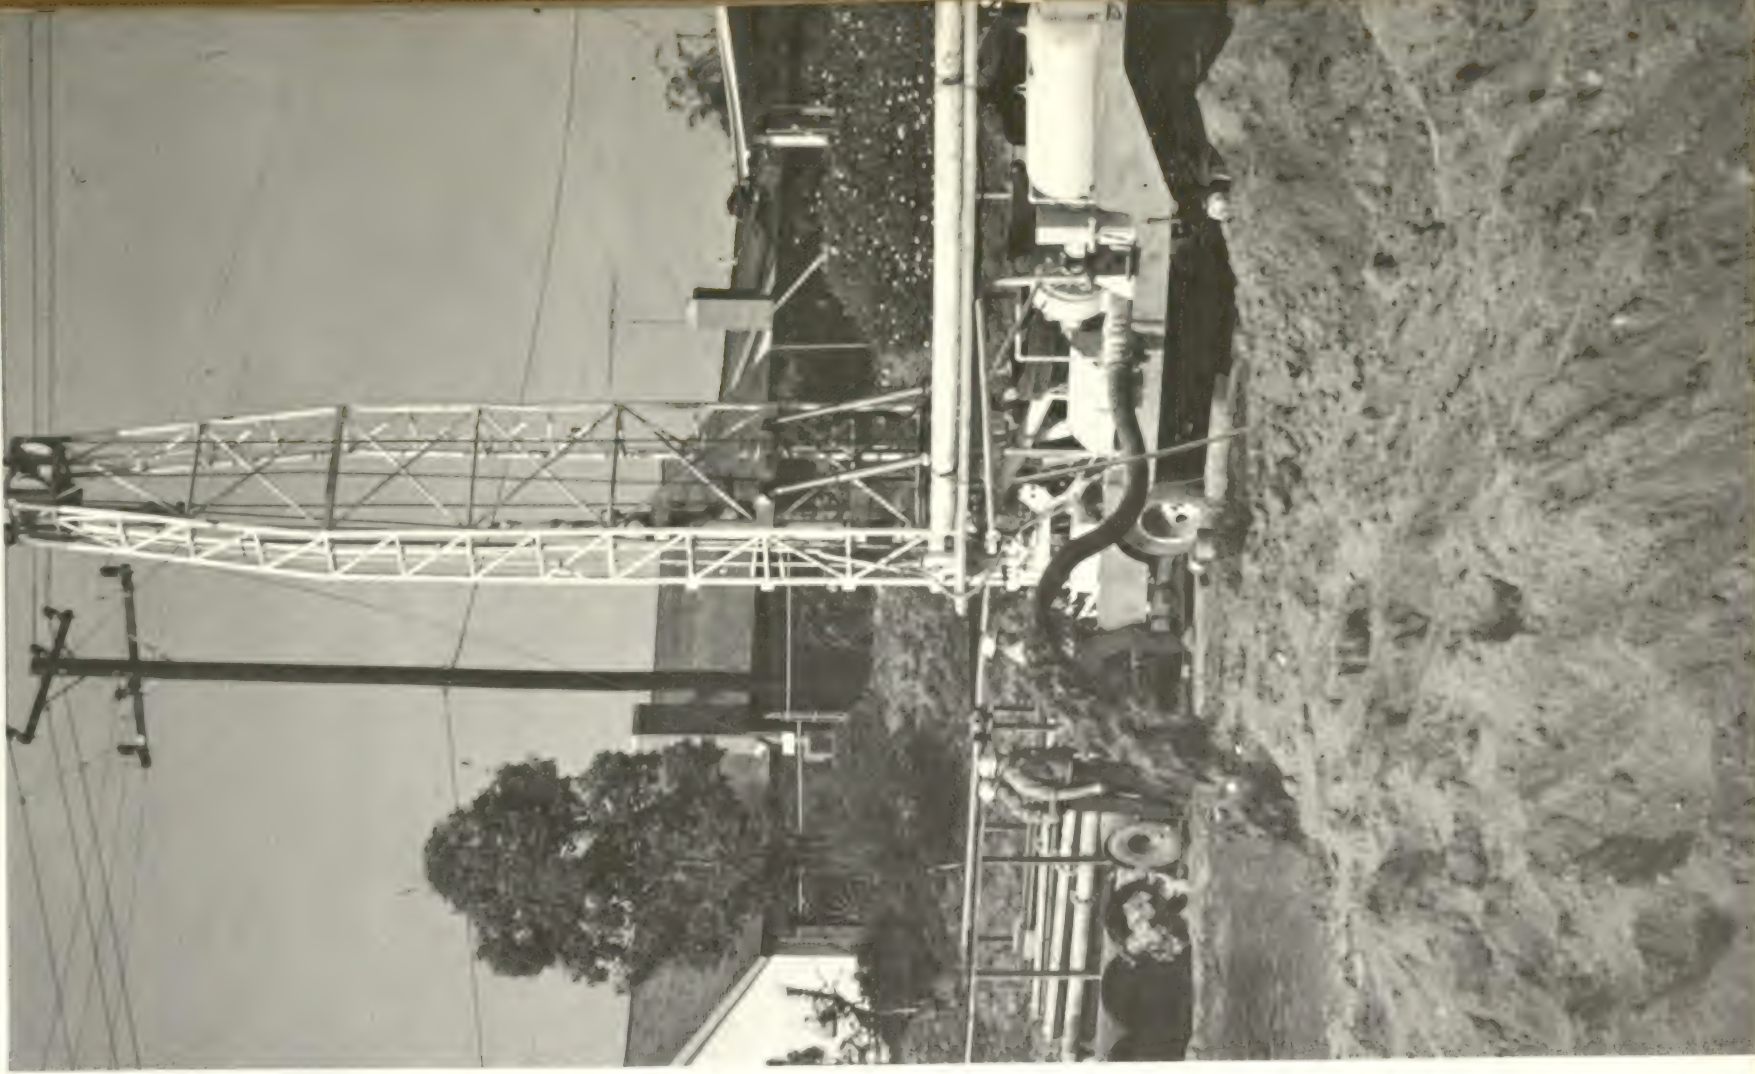
Photo 9. Water well under construction near San Jose Creek and Berkeley Drive. Photo by Goleta County Water District.

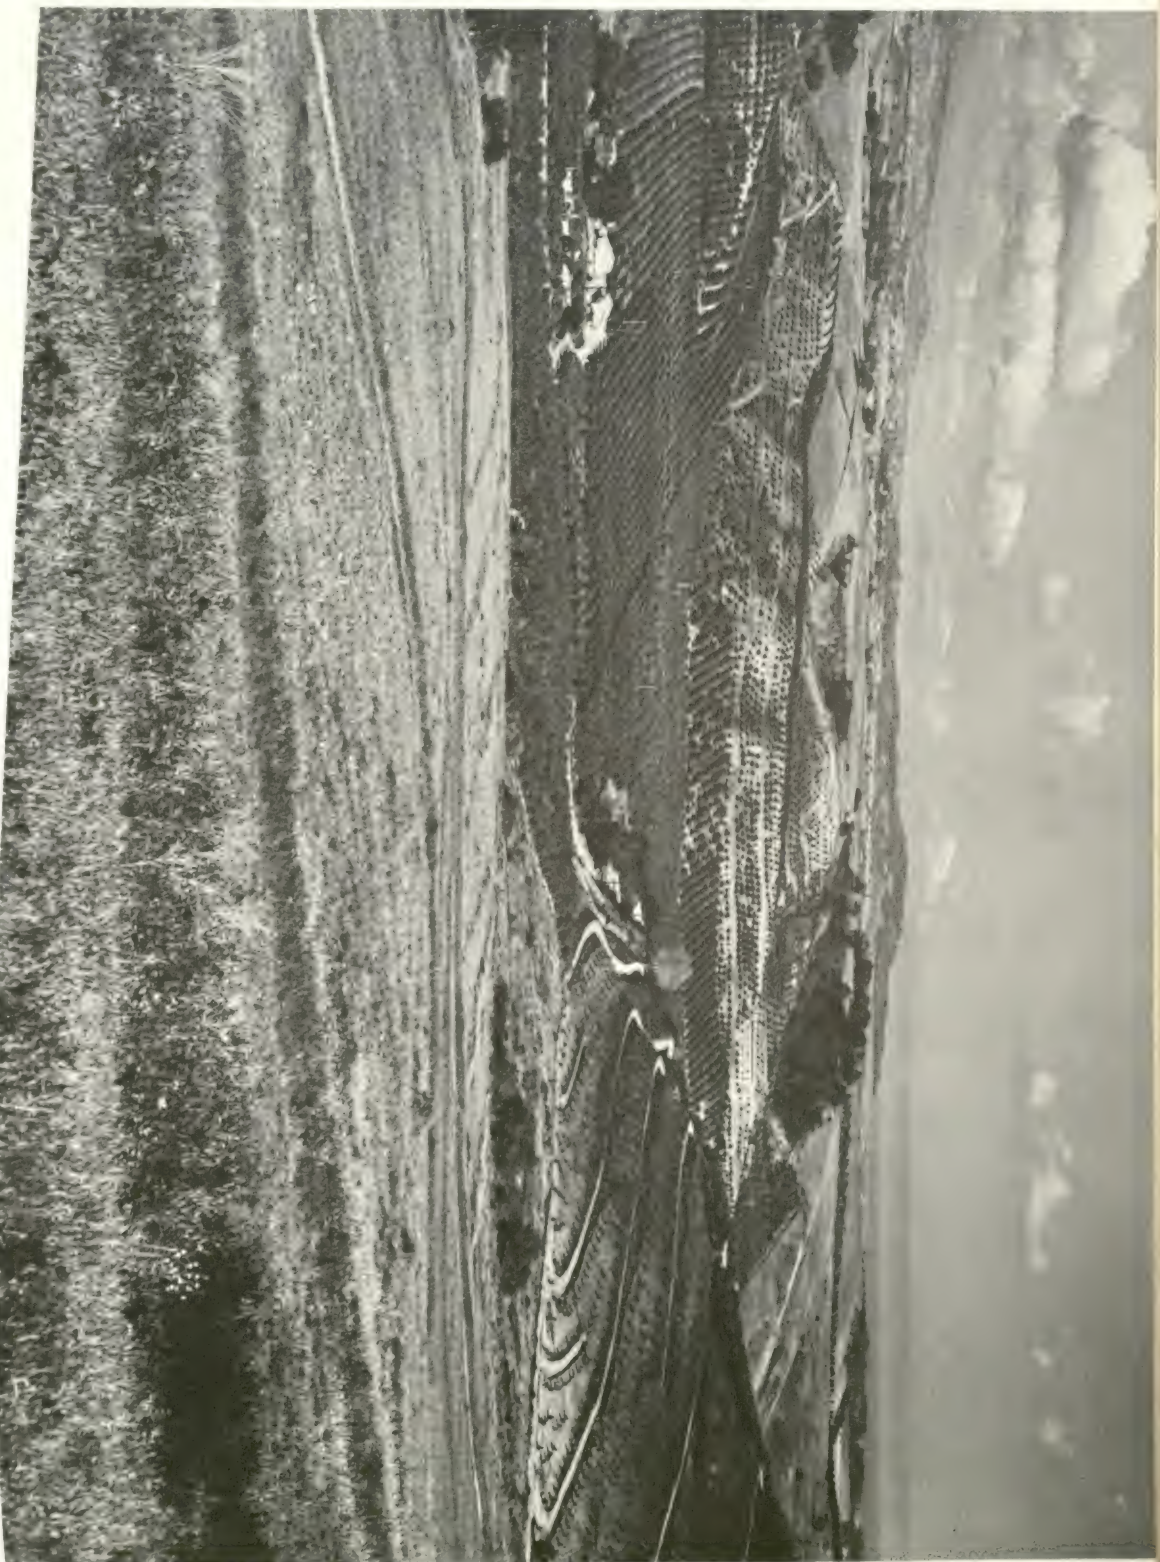
Photo 10. Agricultural development in Glen Annie Canyon. View shows various stages of developing steep eroded land for lemons and avocados. Note diversion terraces with controlled outlets. Photo by Al Robertson.

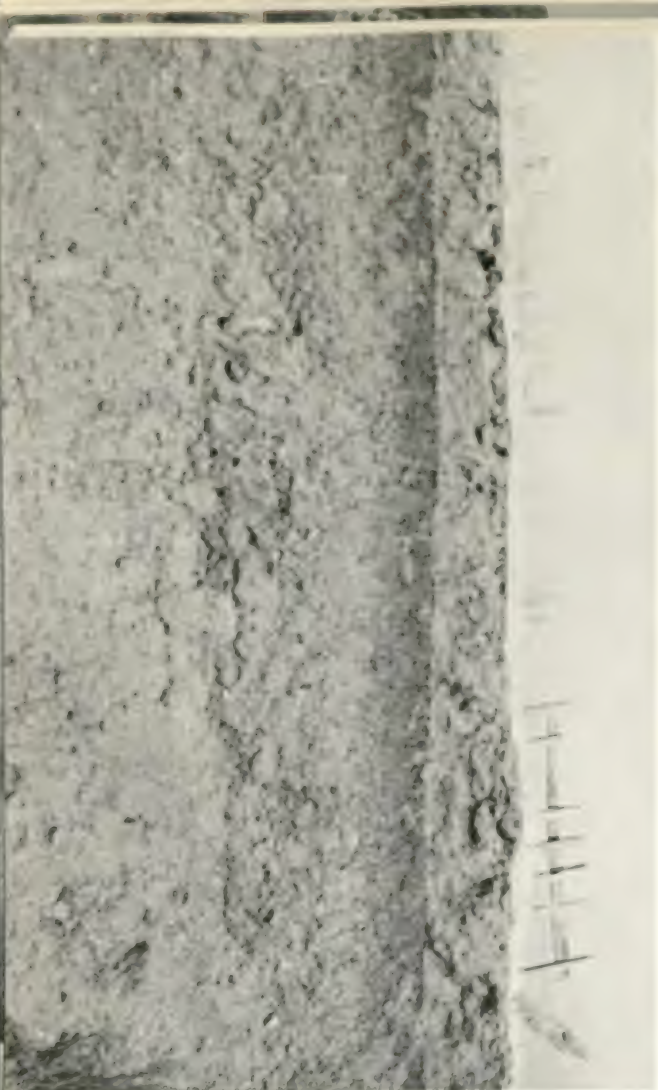
Photo 12. Soil exploration pit in recent alluvial soil, which is deep, well drained, and has no limitations in the profile.

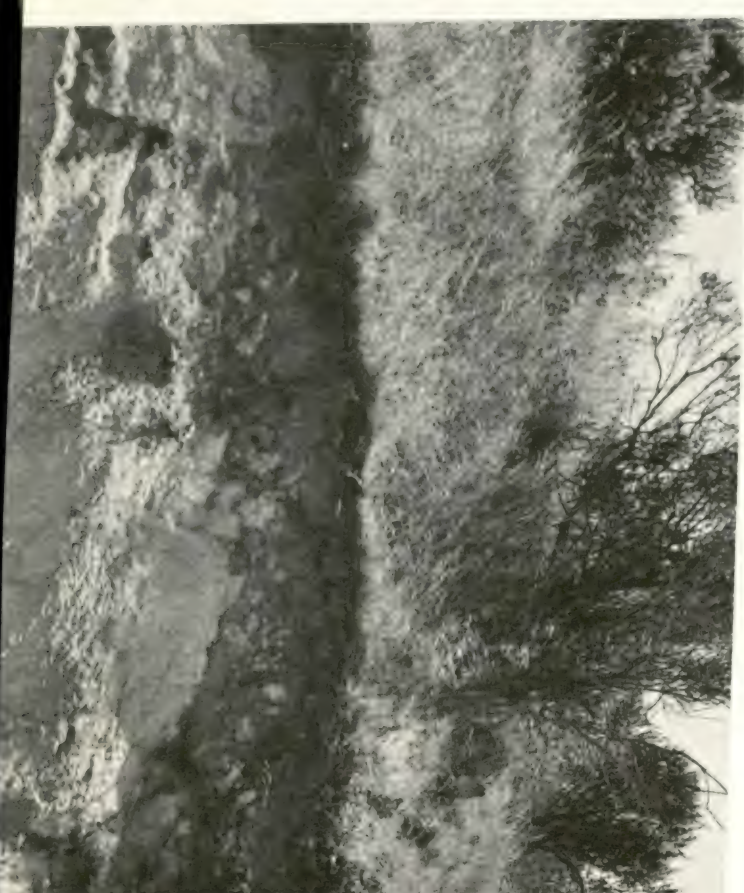
Photo 14. Residual soil. Some of these upland soils are only moderately deep to rock, soft sandstone or shale. These soils present special problems in proper use and management.

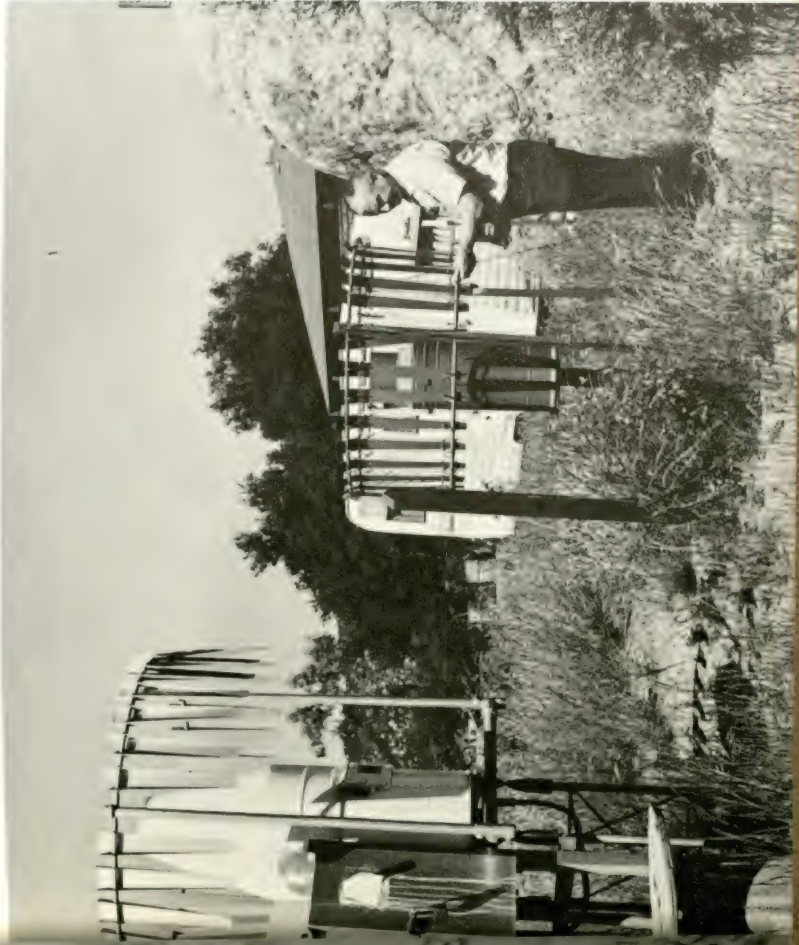
Photo 17. Two recording raingages installed at San Marcos Pass. The near gage records on binary digital punched tape and has telephonic interrogation. The far gage has a pen and chart recording mechanism. Both gages are equipped with wind shields.

Recording gages have various mechanisms for making continuous records of rainfall received. The most accurate types catch the water from the funnel in a bucket which rests on a weighing scale. The scale reading is recorded by a pen on a clock-driven chart or is punched in binary form on a two inch tape. The binary tape data can be reduced to printed form by automatic machines, which results in overall economy even though the punched tape gages cost three times as much as the pen and chart gages. The U.S. Weather Bureau is changing its recording rain gage stations to the punched tape type and as a result a number of pen and chart gages were made available for the Goleta Watershed Survey and have been placed at strategic locations in the study area.

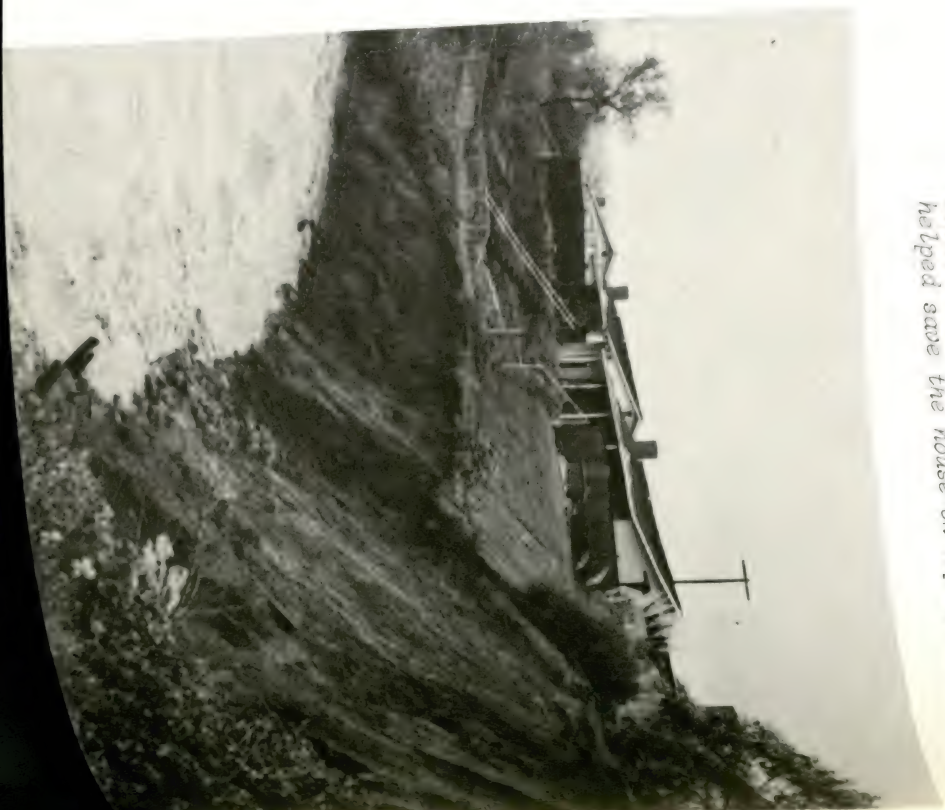
Photo 18. Bank erosion along Maria Ynezia Creek in February 1962. Sandbags placed as an emergency measure to lower center of photo deflected the current and helped save the house on top of the bank.

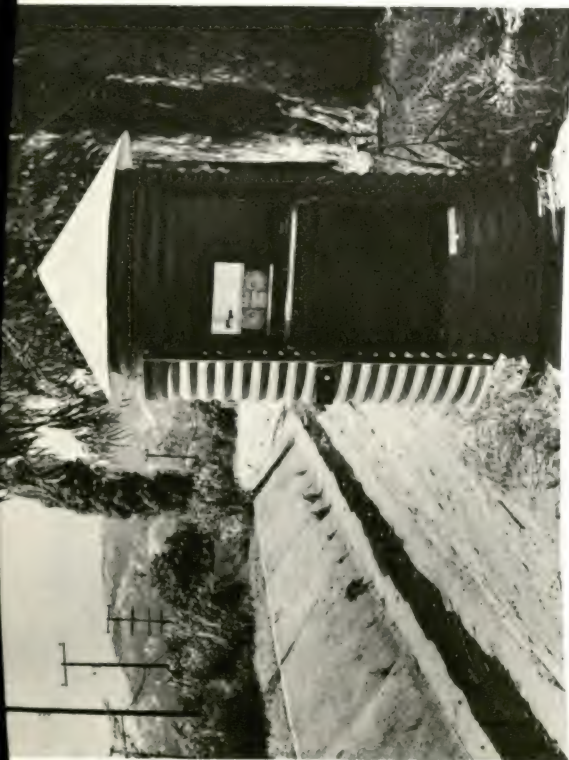
Photo 21. Stream gage installation on San Pedro Creek. The punched tape unit records the stream levels in the stilling well, which is connected to the concrete lined channel by pipes.

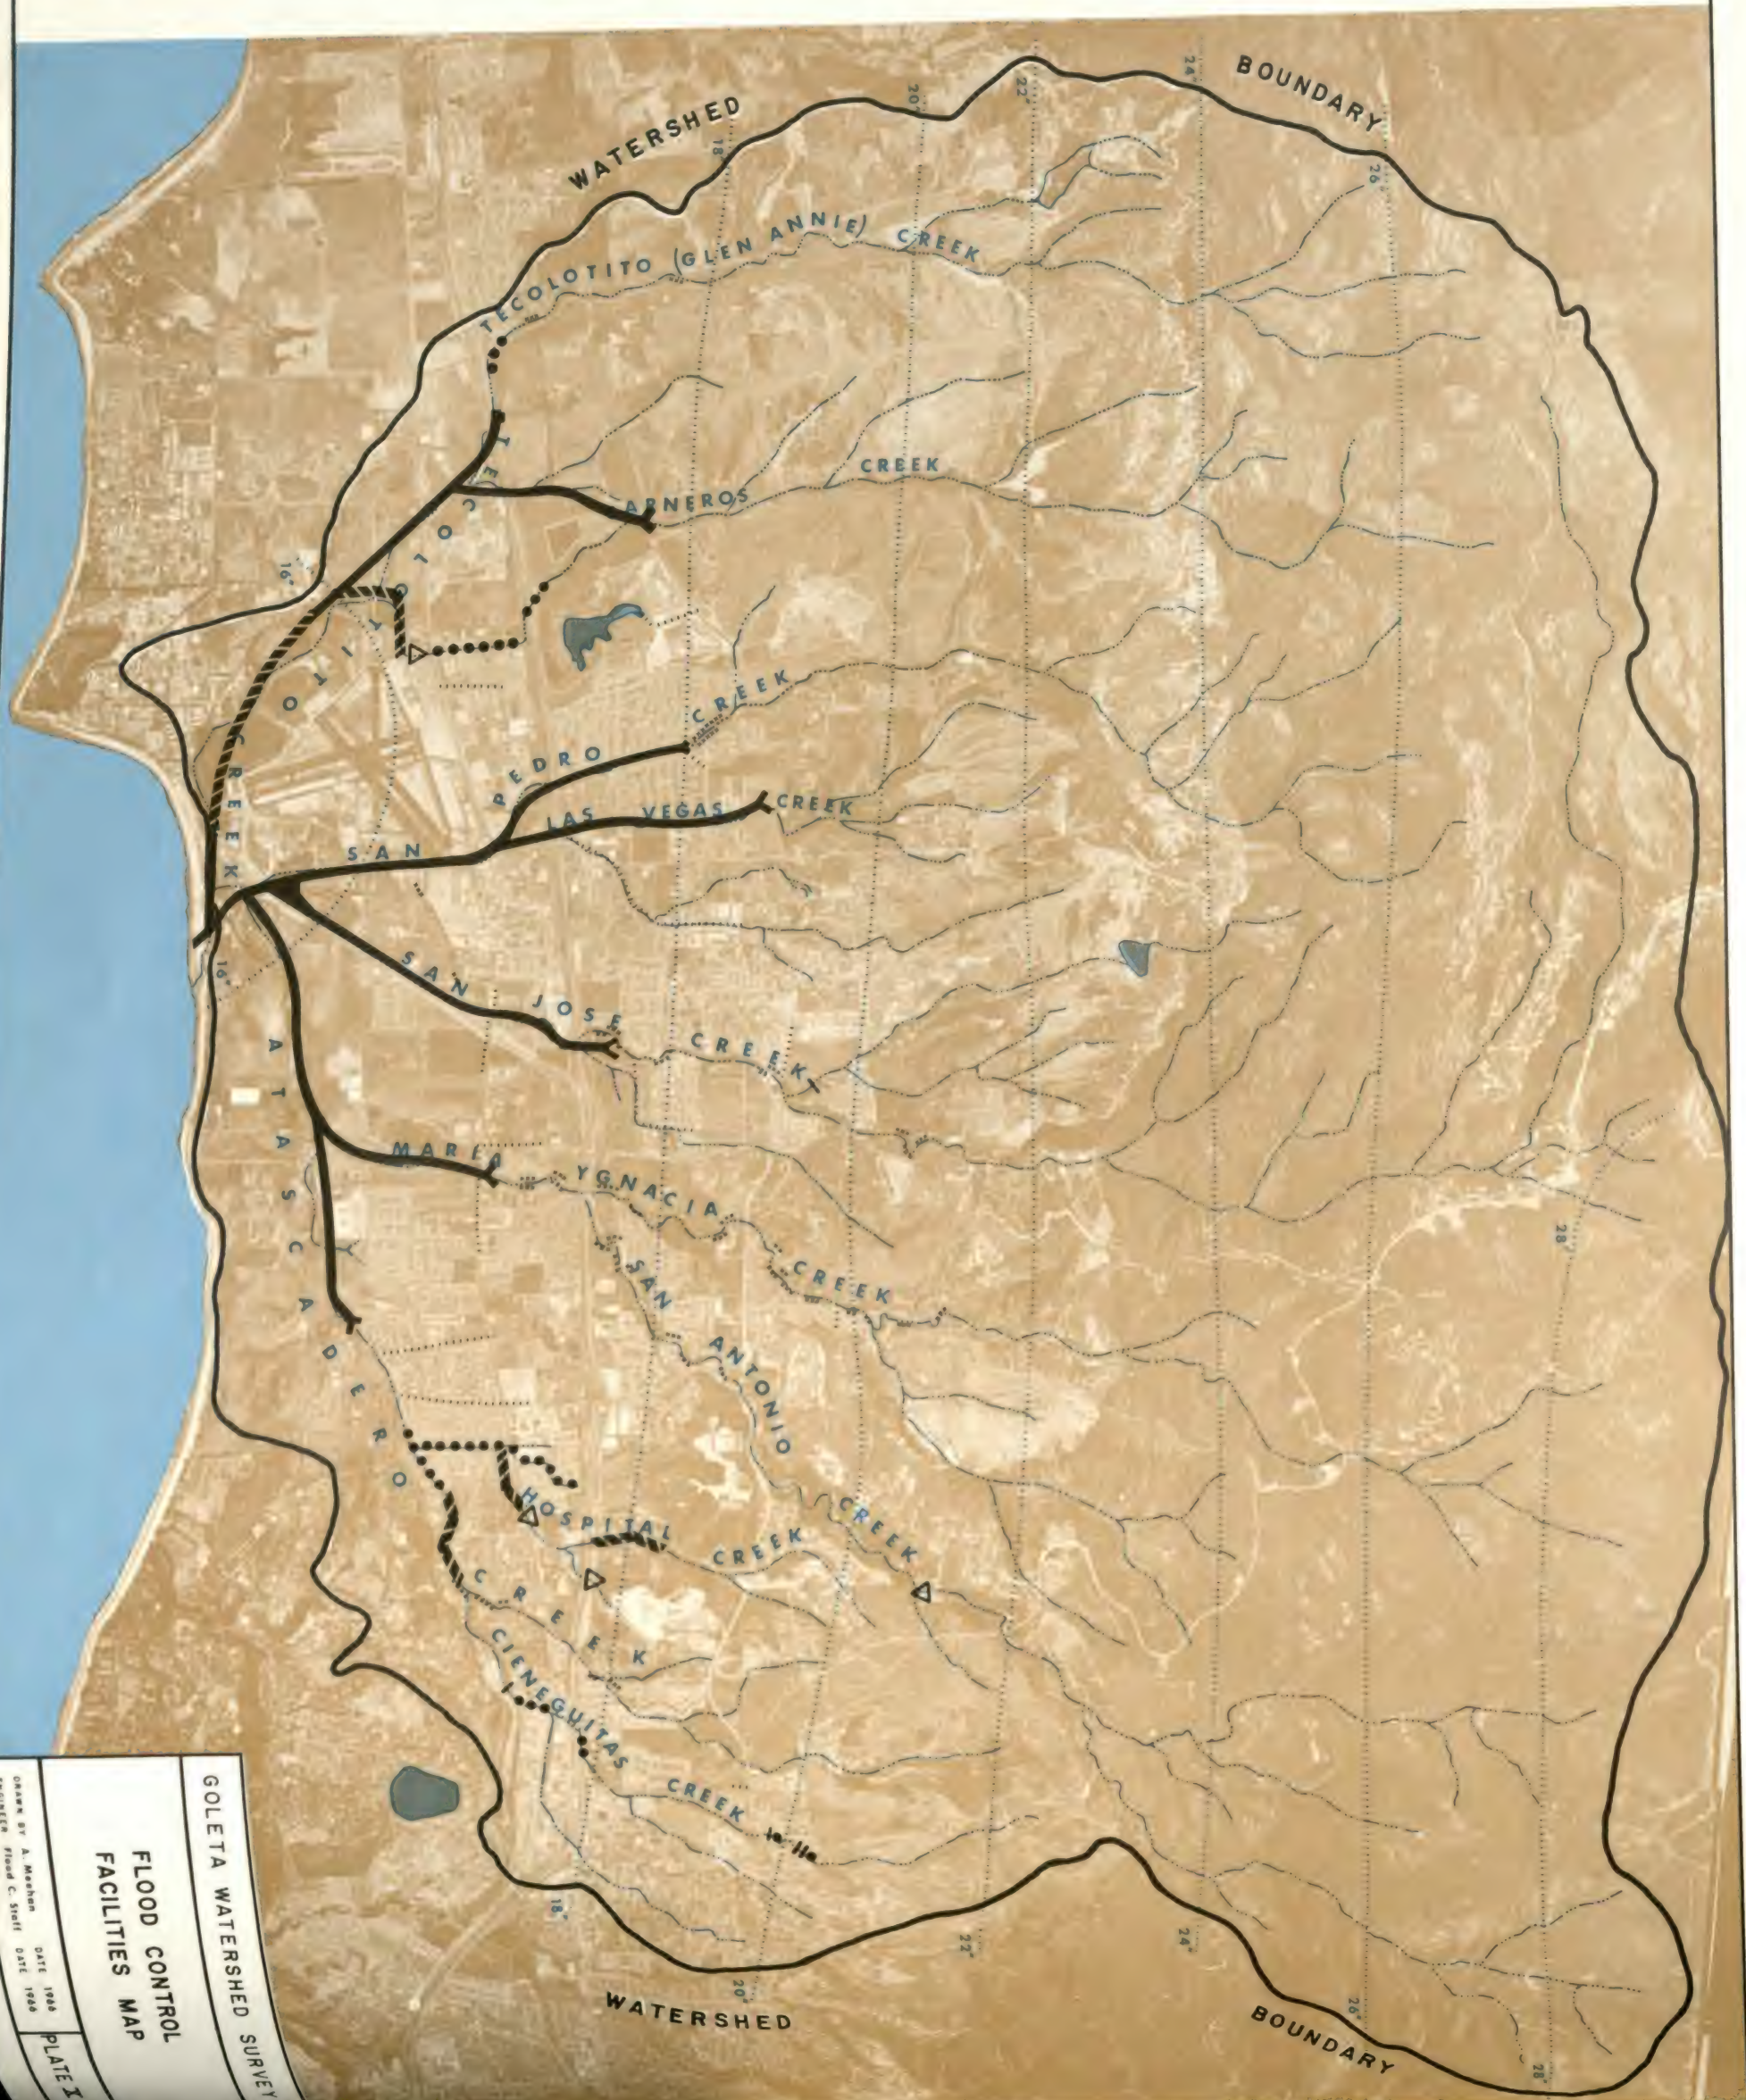
GOLETA WATERSHED SURVEY  
FLOOD CONTROL  
FACILITIES MAP

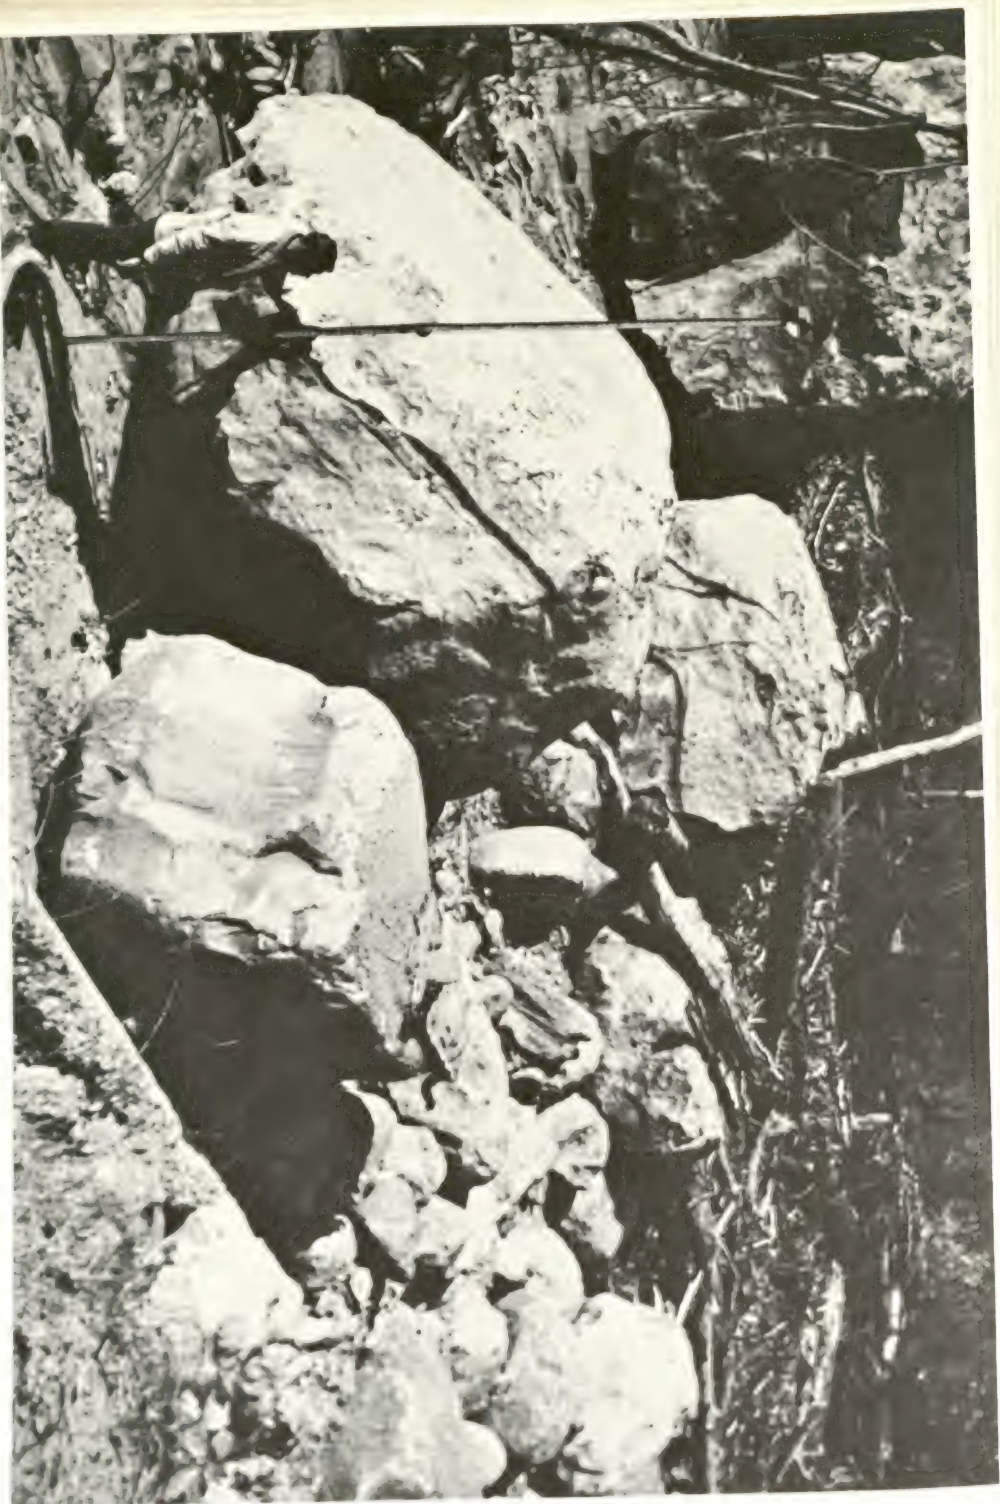
Photo 24. Debris transported by flash flood of November 9, 1964, in San Antonio Creek. The rocks in the foreground were moved about 1/4 mile and weigh up to 430 tons. The logs and tree trunks left in the background by the flood cover about 1/2 acre.

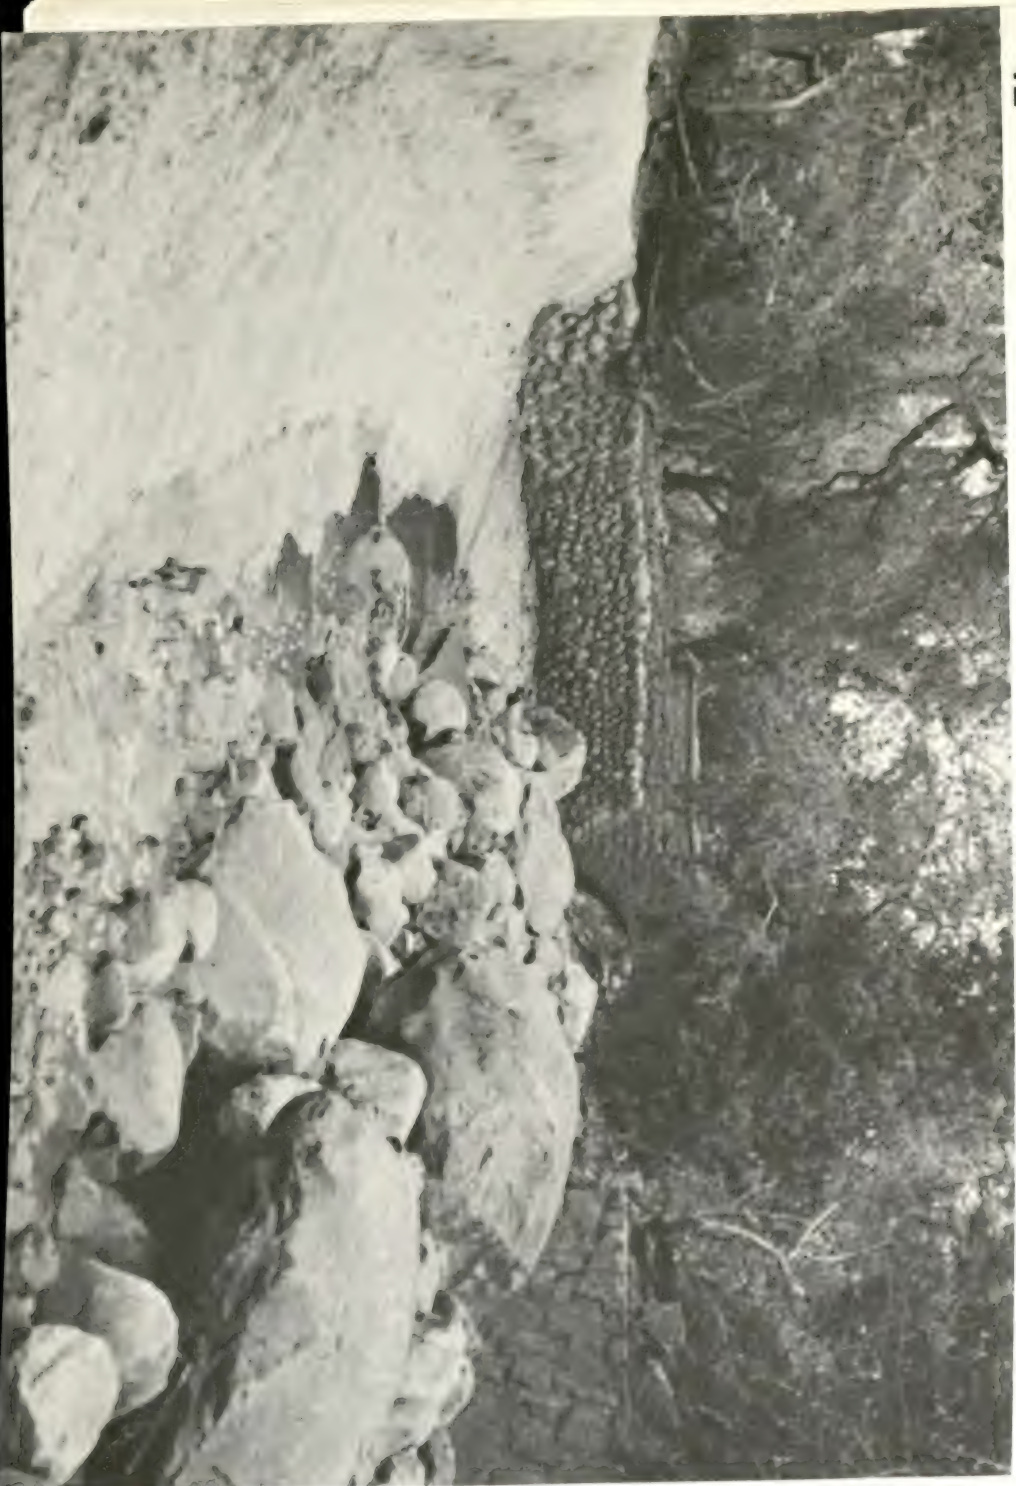
Photo 25. Debris deposits in cross-sectioned channel of Montecito Creek following flood of November 9, 1964. The concrete inlets was completely eroded away upstream of this point.

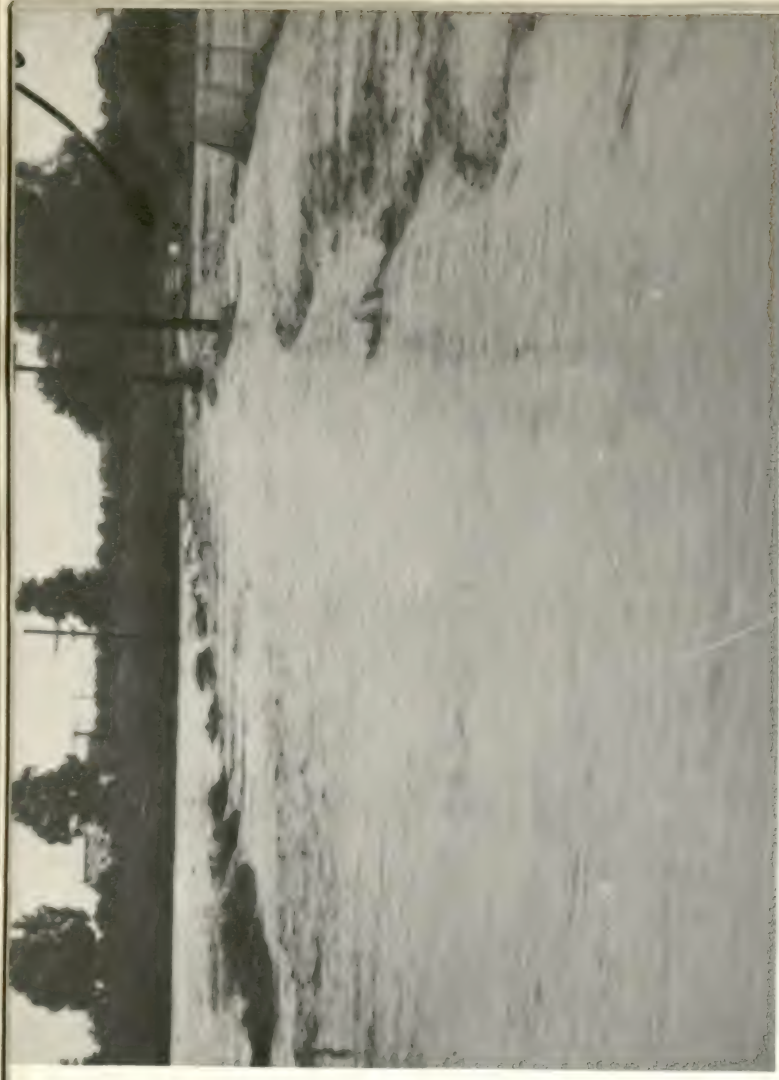
Photo 28. Overflow from Maria Ygnacia Creek flooding across South Patterson Avenue. January 24, 1967. Photo by U.S. Geological Survey.

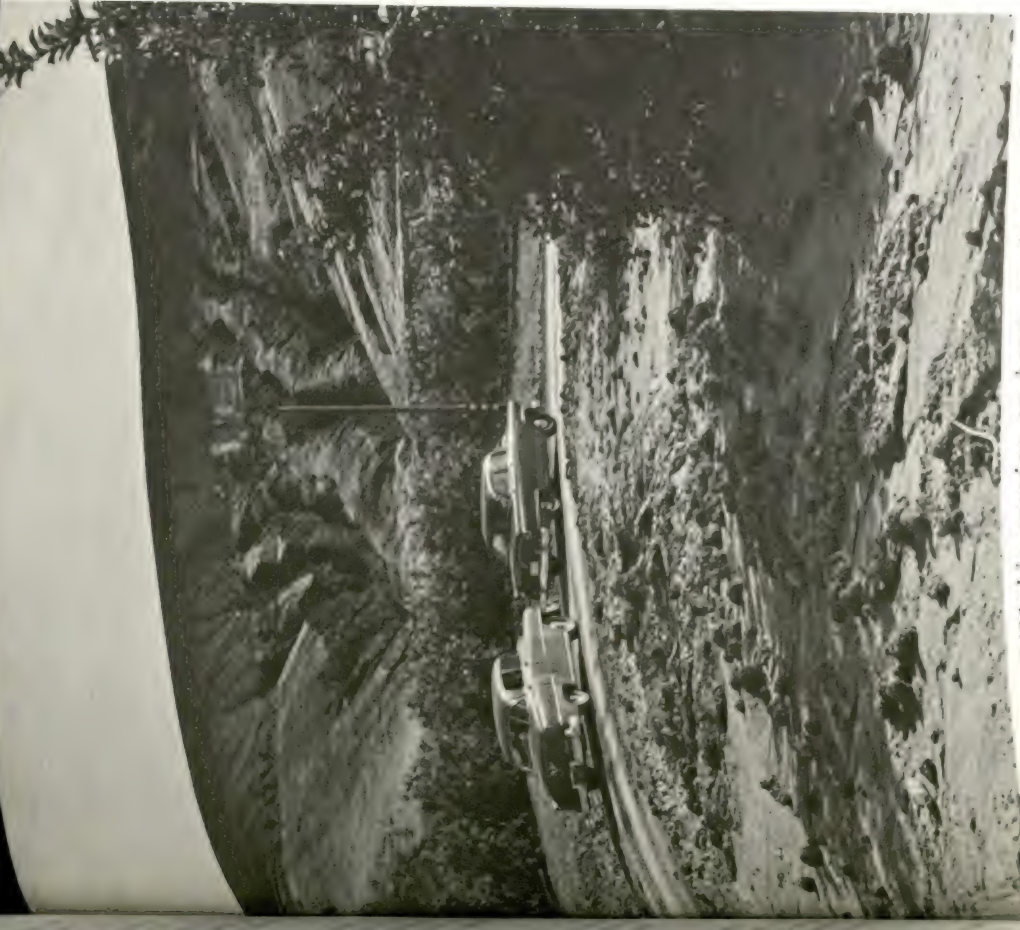
Photo 26. Severe hillside erosion on bare, un-terraced hillside. The sediment from this erosion damaged the orchards below and filled up the stream channels. Photo by Santa Barbara News-Press.
